Alert

Crush Injury to foot when a Plunge Column has moved from its timber base.

Date of incident	02/11/2022	Incident type	LTI Injury
Incident ref number	678340	Contractor	SB3
Sublot	2b	Location	Burton Green Tunnel
Keyword search	Suspected Fracture to Foot/Toe	Reported by	R. Whitehouse

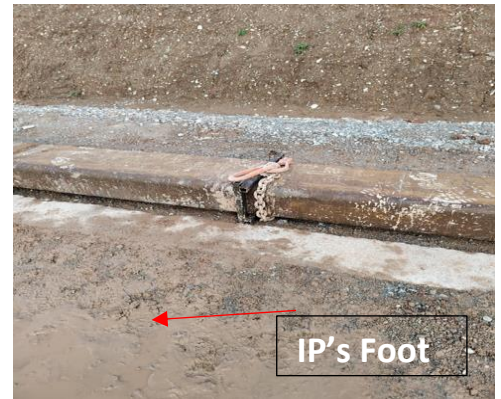
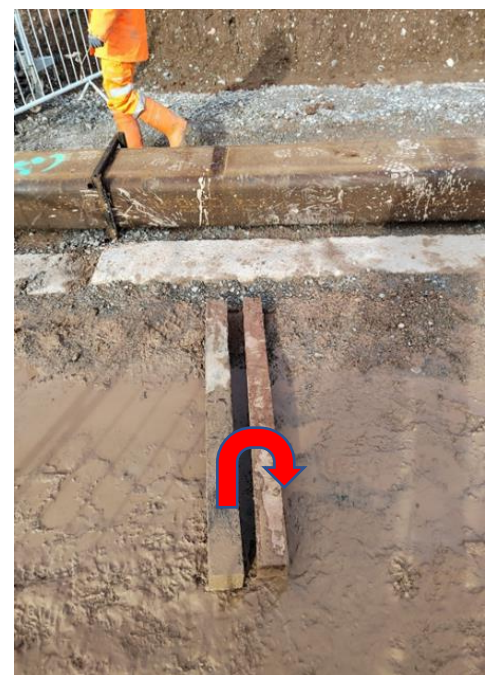
An SB3 (agency) crane supervisor sustained a crush injury to his foot when a plunge column (Rectangular Hollow section filled with concrete-gross weight 6t) moved from a stacked timber and the spacer onto his foot. The column had been lowered to the ground using a set of 2 kidney chains. The column was resting on 2no 4" x 4" timbers (stacked on top of each other) to keep the spacers from coming into contact with the ground. While the kidney chains were being removed, the stacked timbers have "given way" or "rolled" causing the column to move horizontally (approx. 100mm) and downwards approx. 100mm. This motion trapped the operative's foot between spacer and the ground. The column was lifted to release the trapped IP

- The right-hand side 4" x 4" timber has moved horizontally causing it to roll off the bottom timber, caused by the weight of the Plunge Column.
- Stacked timbers should be avoided, single sleepers should be specified for use in storing Plunge Columns

- The Plunge Column was re-attached to the kidney chain and lifted.
- IP was removed from the site and taken to Hospital.
- Photographs were taken
- IP and witnesses were interviewed.
- The incident investigation team was identified and the 24hour call arranged.
- The area was demarcated and made safe.
